**MARYLAND INVENTORY OF
HISTORIC PROPERTIES**

Survey No. B-4606

historic Ordinance Storehouse and Coal House

street & number Leahy Street, N. of Ft. McHenry National Monument & Historic Shrine Not for publication

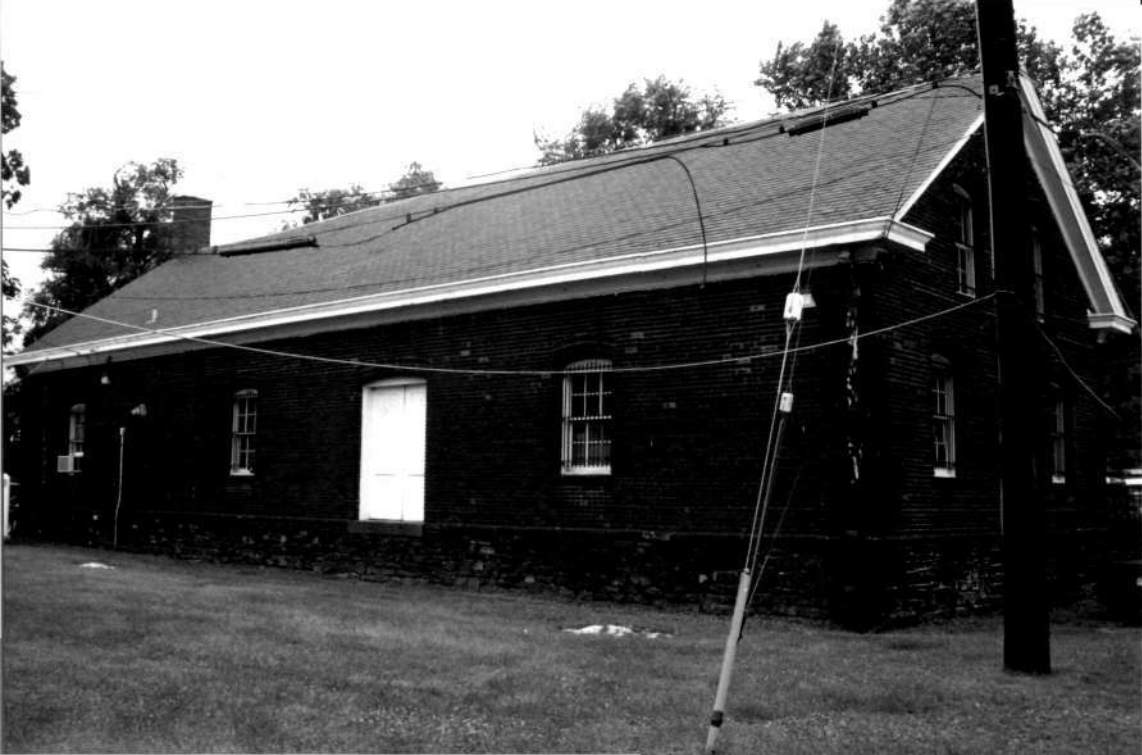
1/8

· NORTH FACADE

The north facade of the storehouse is dominated by a pair of off-center double doors which appear to be original. The doors are non-functioning, however, as they are nearly four feet from the ground, and there are no stairs or platform leading up to them. The doors, which are unglazed wood frame are filled with diagonal panel wainscoting. There are three windows on this facade, all irregularly spaced. The windows are identical on all facades, and are six over six double hung sash, and have iron bars covering them. The window surrounds are minimal, but each has a brick sill, and each is topped with a segmental arch composed of three levels of rowlock-laid bricks. Decorative elements on the wall itself are limited to a heavy yet plain wooden cornice. As with the other sides of the structure, the stone water table extends approximately 3' 6" from the ground.

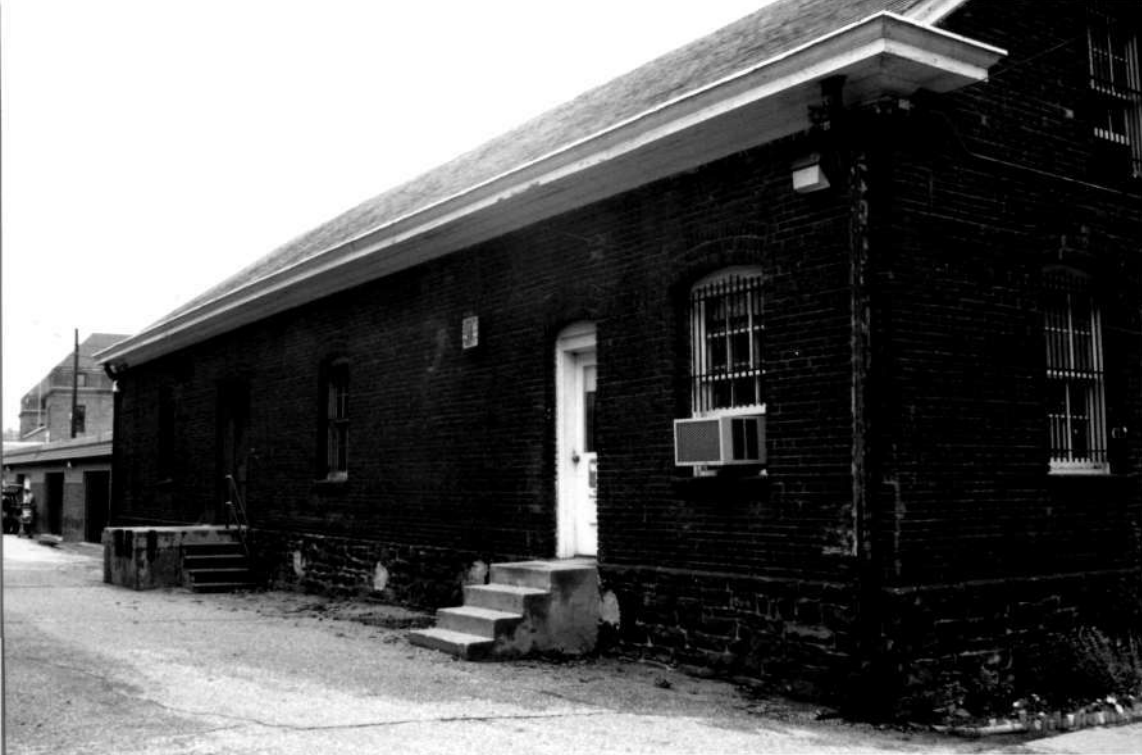
- ORDINANCE STOREHOUSE
- BALTIMORE CITY, MD
- KATHERINE BASYE
- 13 AUGUST 1996
- US ARMY CORPS OF ENGINEERS, BALTIMORE DISTRICT
10 S. HOWARD ST, BALTIMORE
- SOUTH FACADE
- 2/8

The south facade is the primary loading side for the storage area. As with the north side, there are a pair of wooden double doors, and although these doors are new, they very closely replicate the original doors found on the north side, with the exception of not being painted white. The pair of doors have a small concrete loading dock which projects five feet out from the door and is eight feet long, as well as a set of four stairs on the right side. In addition to the pair of doors, there is another door to the right, as well as three windows. The single door leads to the administrative area, and has a set of four concrete stairs leading up to it.

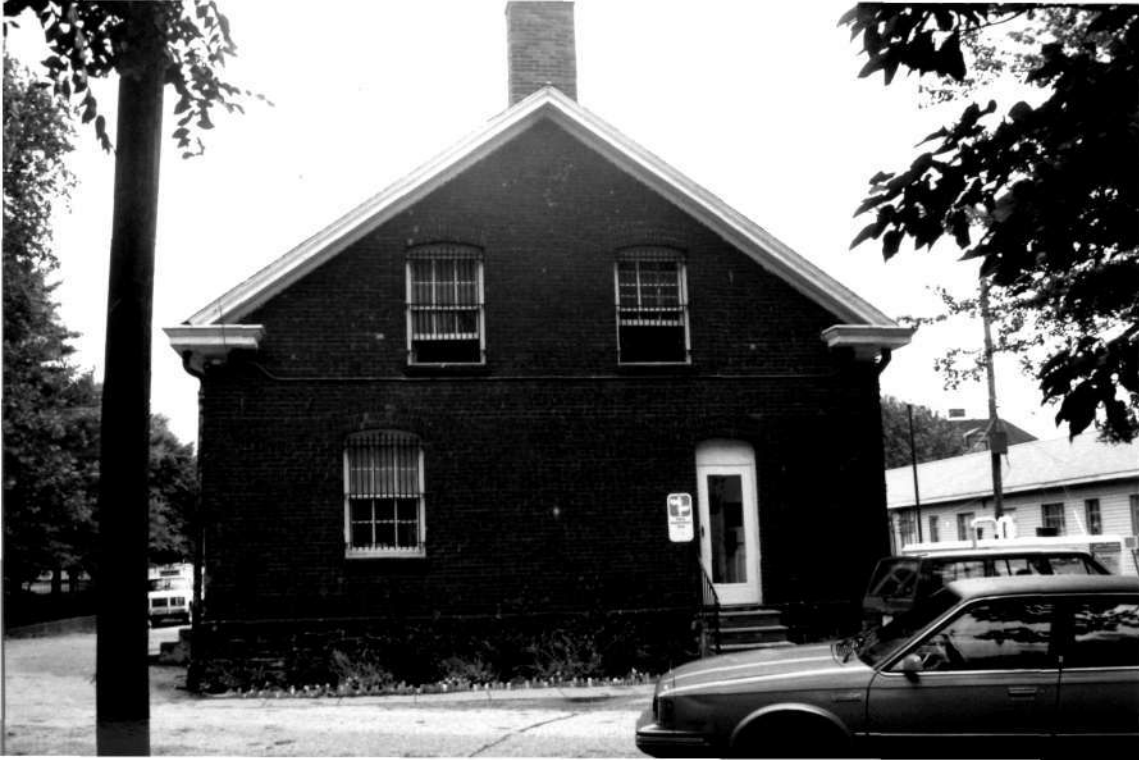
- ORDINANCE STOREHOUSE
- BALTIMORE CITY, MD
- KATHERINE BASYE
- 13 AUGUST 1996
- US ARMY CORPS OF ENGINEERS, BALTIMORE DISTRICT
10 S. HOWARD ST, BALTIMORE
- EAST FACADE
- 3/8

The east facade is currently used as the main entrance for the administrative area. The gable is decorated with rake moldings that abut cornice returns, extending about three feet beyond the corner. The facade is symmetrically laid out with a window and door on the ground floor, and two windows above them which provide light to the attic. The three windows configure to the others, but the door is a modern metal frame with a large glass insert. Below the window on the left is an air duct covered with a three-bar iron grate which leads to the crawl space. This is a rough opening in the stone water table to promote ventilation in the three foot space between the ground and the floor joists. There is a brick square chimney apparent at the peak of the roof, but the facade is flush.

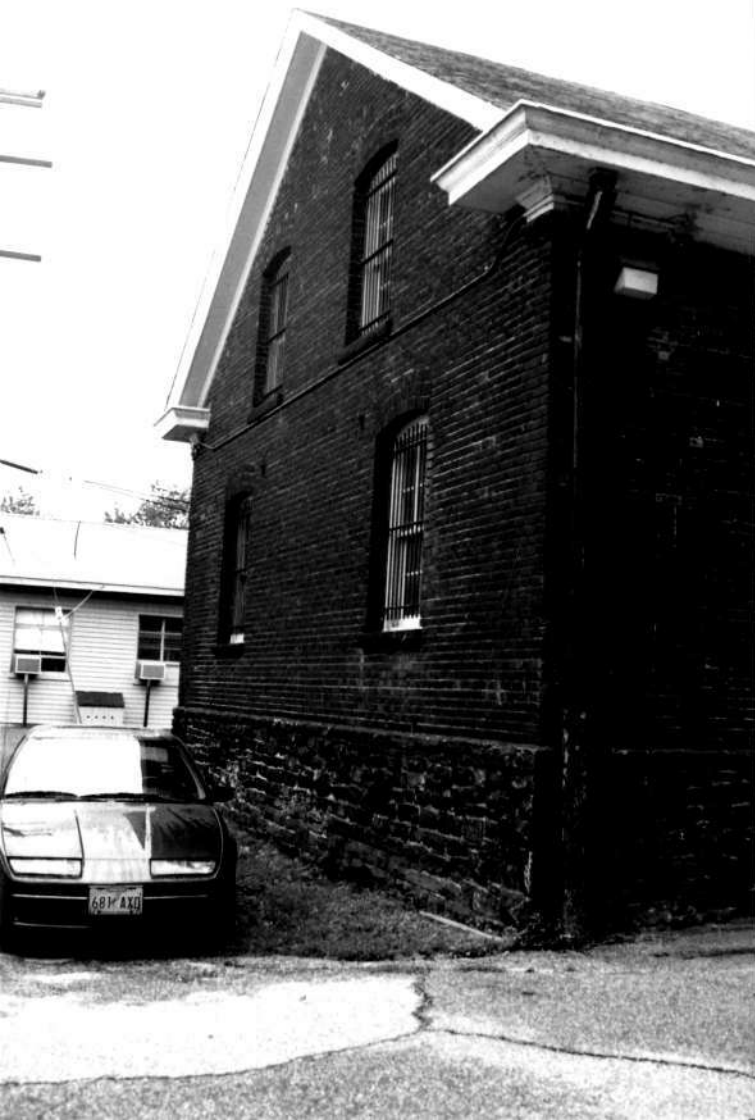
4/8

WEST FACADE

The west facade has four windows, two on the ground floor, and two in the attic, which resemble the other windows of the structure. There are two iron-grate air ducts, similar to the one on the east facade, which provide ventilation for the crawlspace. Decorative elements include the same rake moldings and cornice returns as found on the east facade.

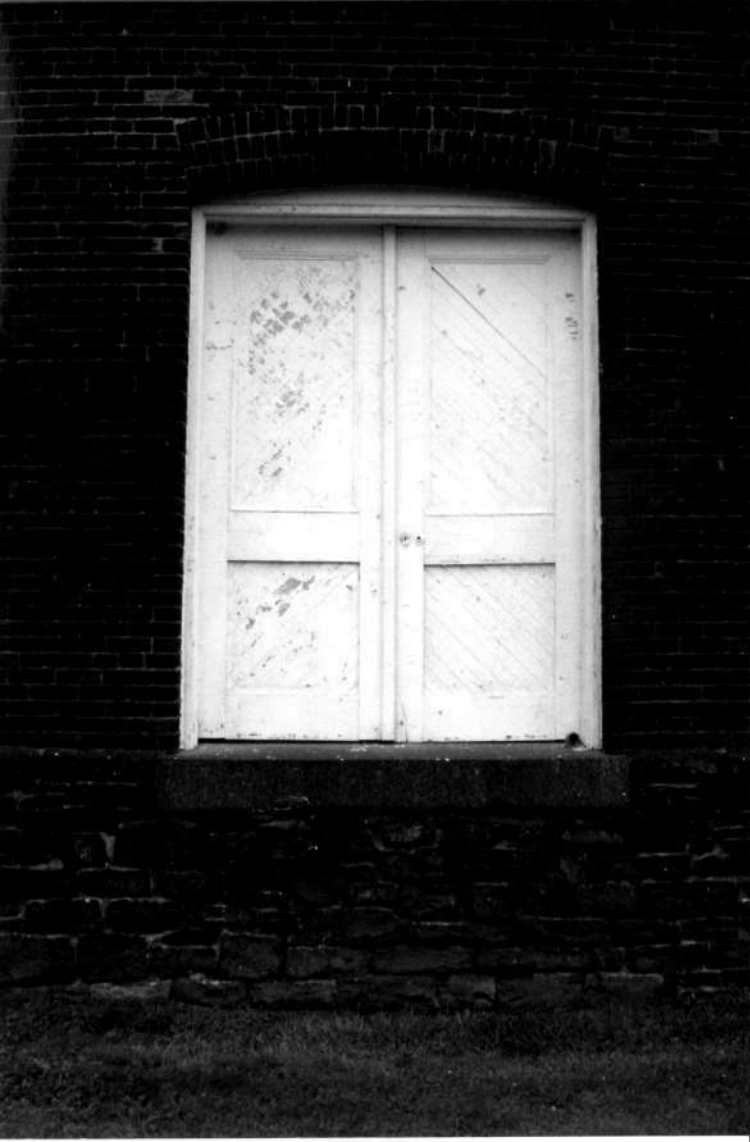
5/8

DETAIL OF ORIGINAL DOORS, N. FACADE

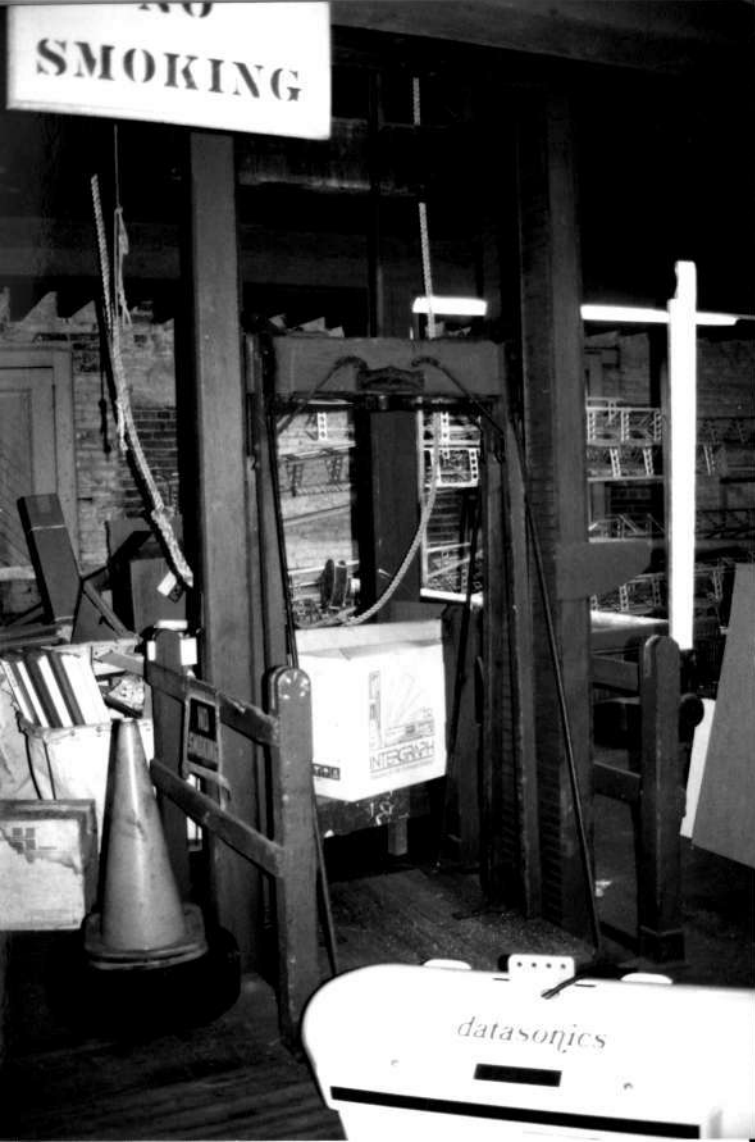
6/8

MANUEL FREIGHT ELEVATOR

Towards the center of the room is the hardware and tracks for the manual freight elevator. The two piers, each approximately 15 feet high, support the tracks and are covered with the same beaded board paneling found on the partition laid horizontally. Surrounding the one-foot deep recess is a fence-like structure which swings up on the north and south sides to allow for easy loading and unloading. The elevator itself is a wooden platform that is held with iron and wood braces, connecting it to a three foot long 5" x 8" beam holding the hoisting cable. The beam is fitted with a plaque reading "Snowden and Cowman, Baltimore, MD." The pulley system and counterweights are located in the attic. There is one large, nearly four foot diameter wheel on which the pull rope is wound and the counterweights are held. On the opposite side of the opening is a gear cog which controls the hoist cable. The beams that hold these elements are attached to the rafters in the ceiling. There is a fence-like barrier with two gates surrounding the opening identical to the railings on the ground floor.

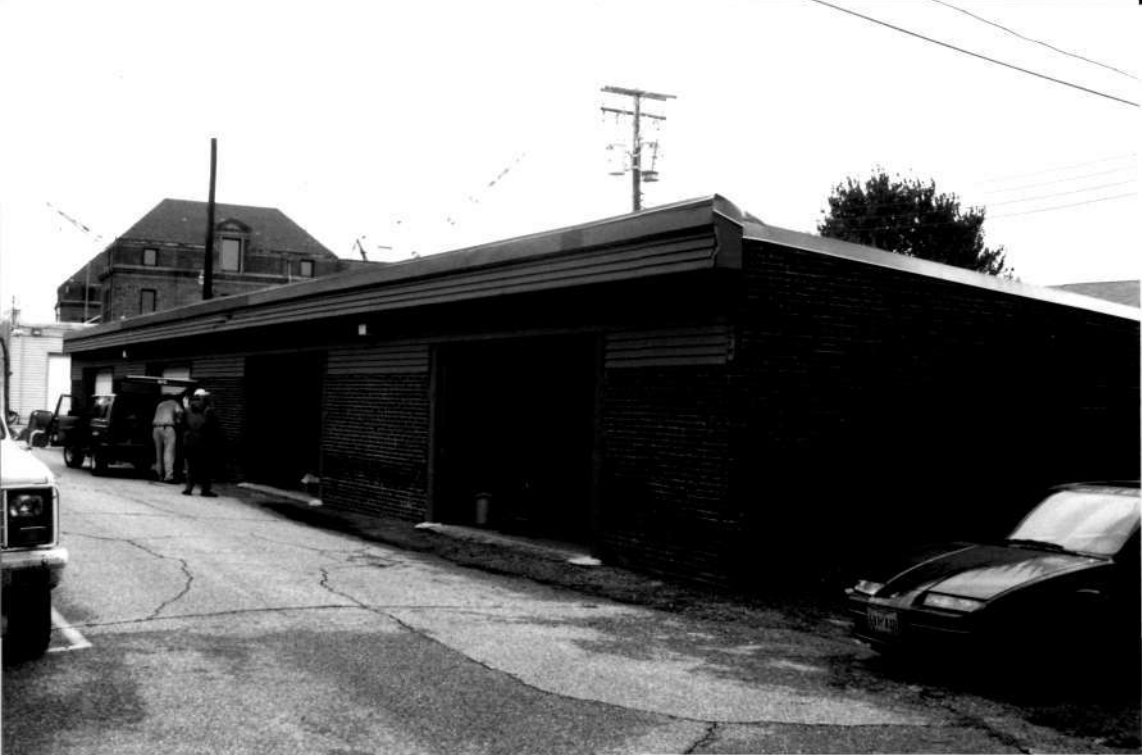
7/8

SOUTH FACADE

The structure is composed of four roughly identical garage bays, each having an overhead door on the south facade. The north facade is identified by four windows, all of which have been covered over. The opening on the northeast corner is the only opening which has been partially bricked-in, as it was a door which was later turned into a window. The east and west sides have no openings and no distinguishable features.

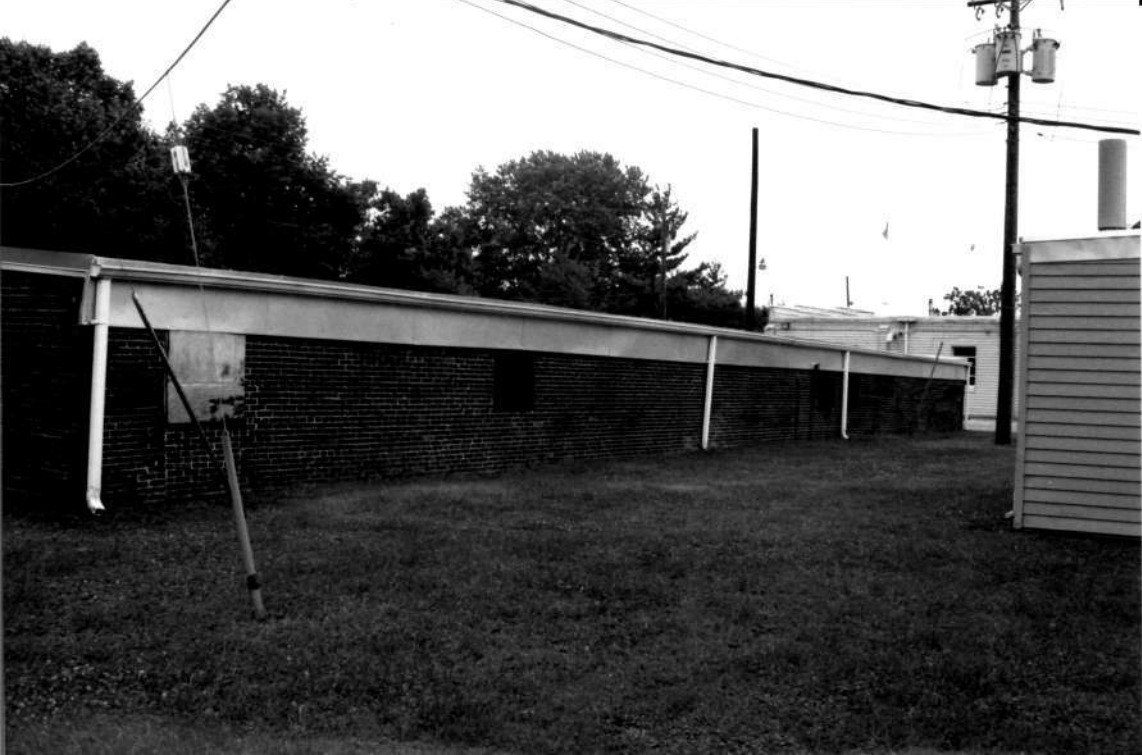
8/8

NORTH FACADE

These two structures sit adjacent to one another on the edge of the Patapsco River, due north of Fort McHenry, Baltimore, Maryland. The buildings are both in relatively good condition, although the coal house does have some structural damage on the Northeast corner. Neither structure has had extensive restorative work done, but both have had some interior renovations.
